Home Inspection Report

PROPERTY INSPECTED:
31 Hanley Street
Toronto, ON M6S 2H3

Date of Inspection: 05/05/2021

Inspection No. 141168-374

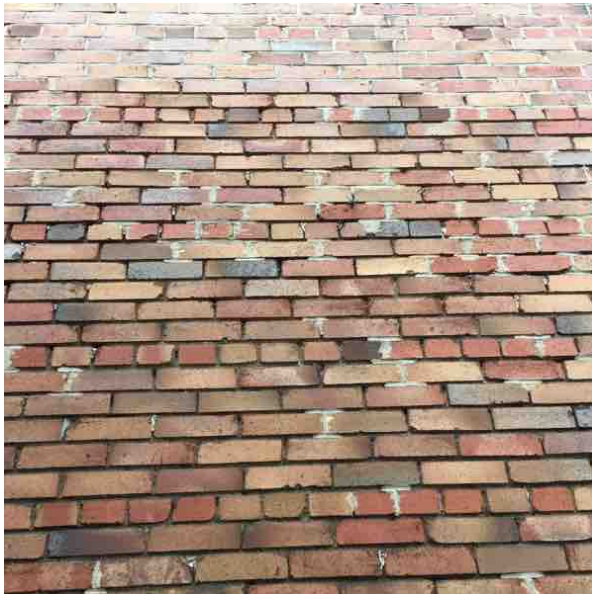
3.4.2 **Exterior brick has minor cracks, deterioration and missing mortar in some locations. Recommend a Mason or qualified contractor tuck point to repair, as well as to add tuck pointing to an ongoing maintenance schedule every few years.**

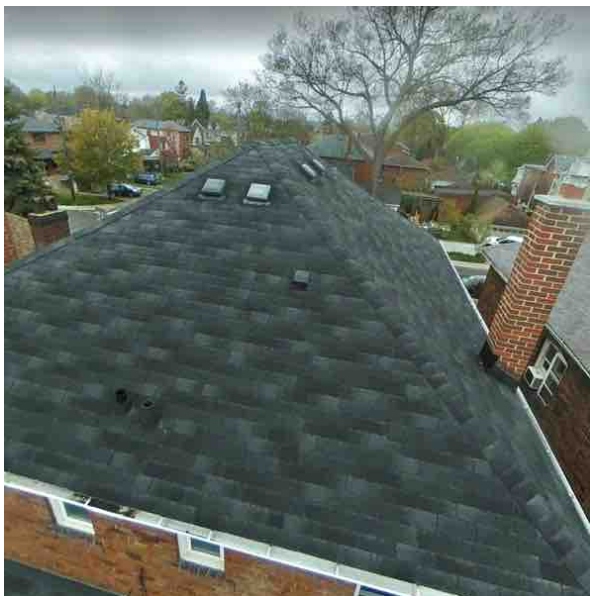
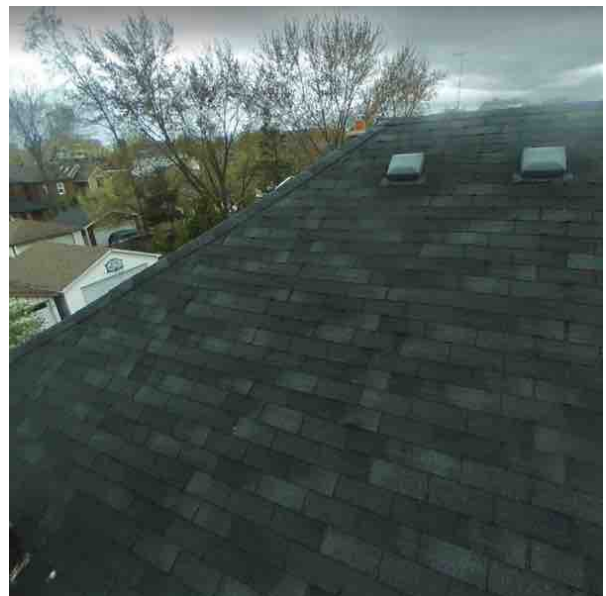
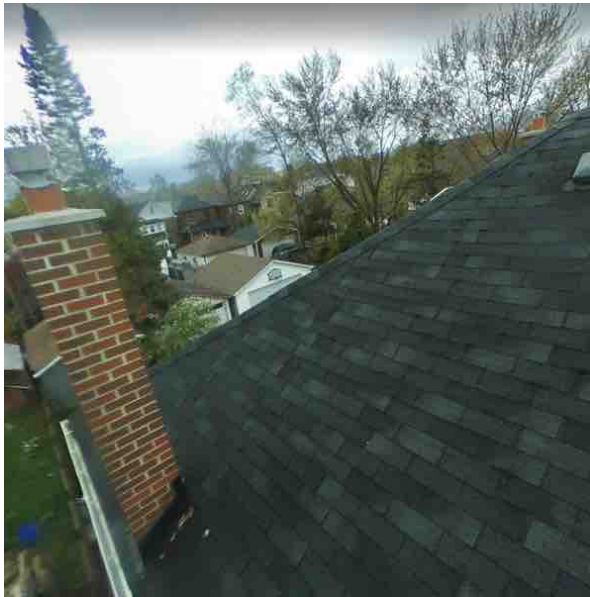
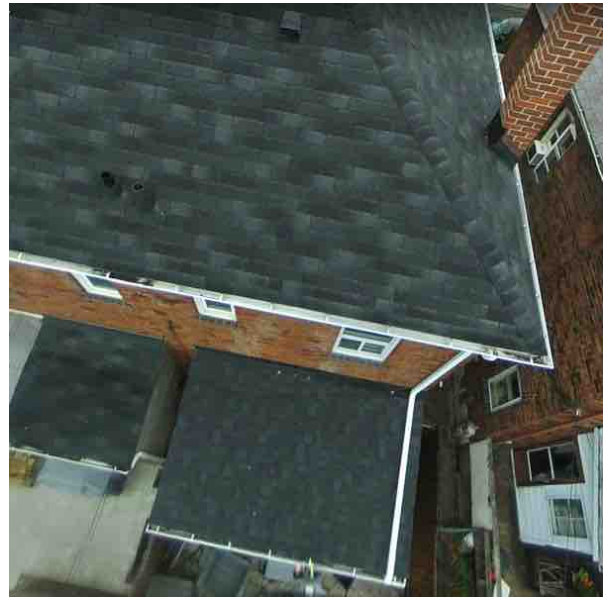
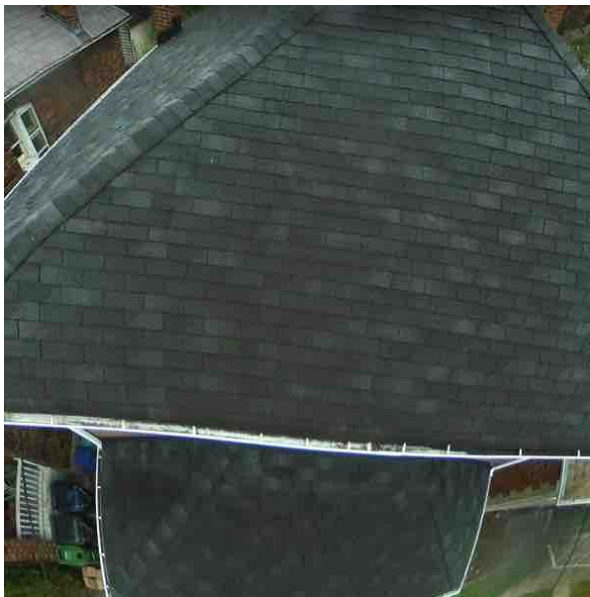
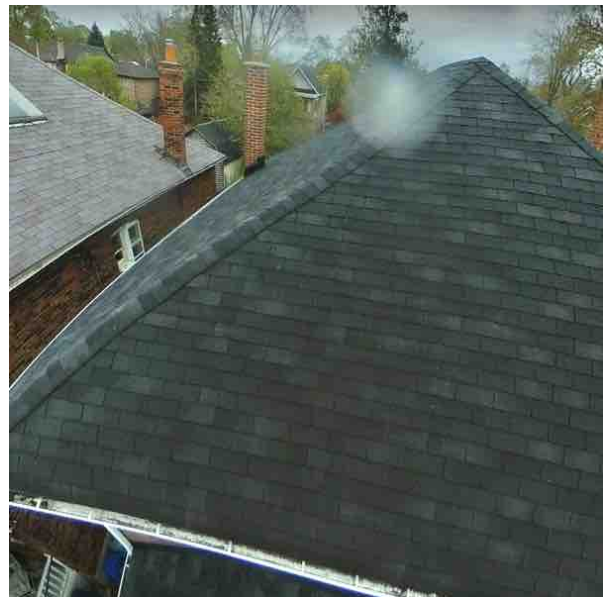
4.2.4 **Asphalt shingles are standard quality, approx 12 - 14 years old, showing some lift / age, nearing end of life cycle and in satisfactory condition.**

Typical life expectancy is around 15 years.

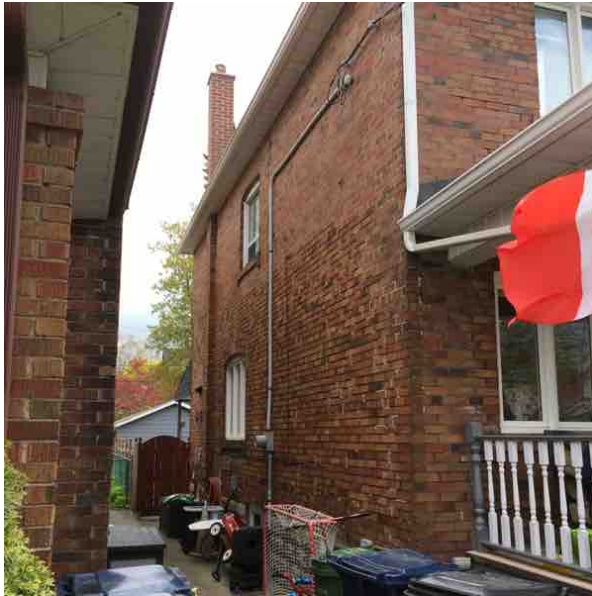
8.3.2 Overhead service entrance cables to a meter located outside at NE corner.

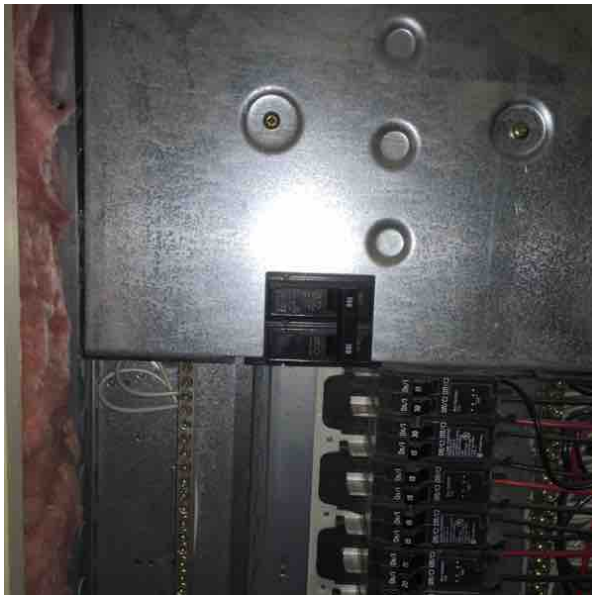
8.5.2 The main disconnect for the electricity going into the distribution panel, is the 100 amp breaker, located at the top of the panel.

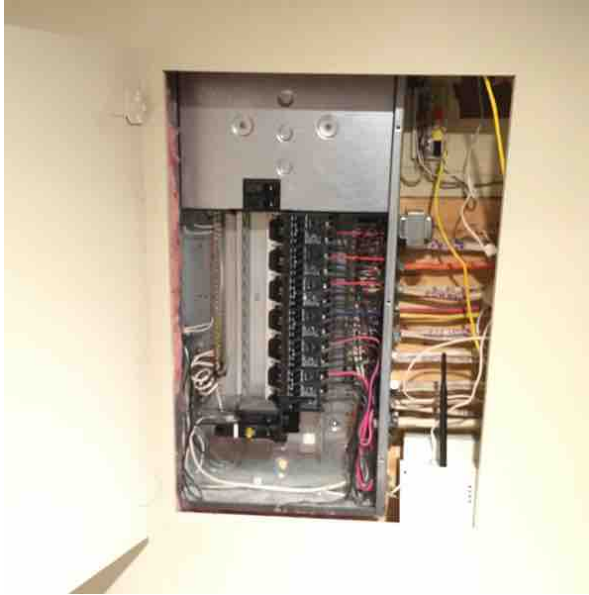
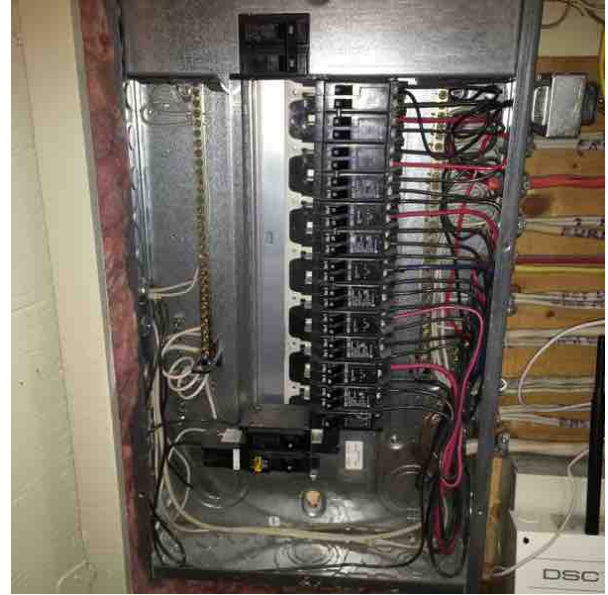
8.6.2 100 amp Distribution panel has room for expansion, has breakers, grounded copper wiring, showing no scorching or burn marks and is functional.

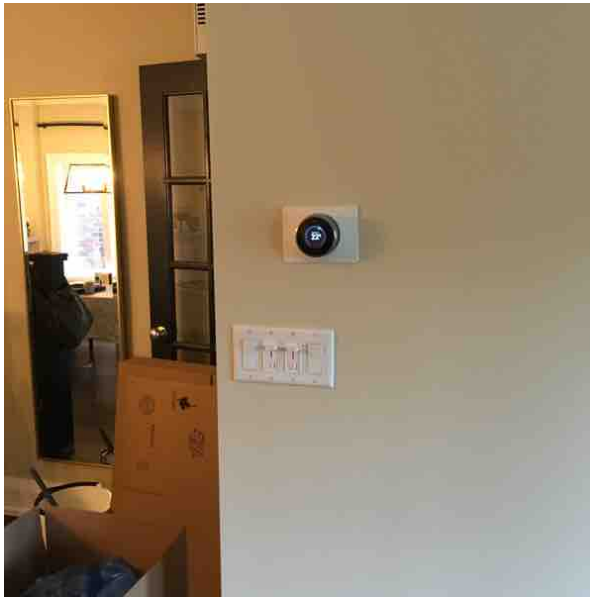
9.2.2 Programable thermostat is located on front entrance wall.

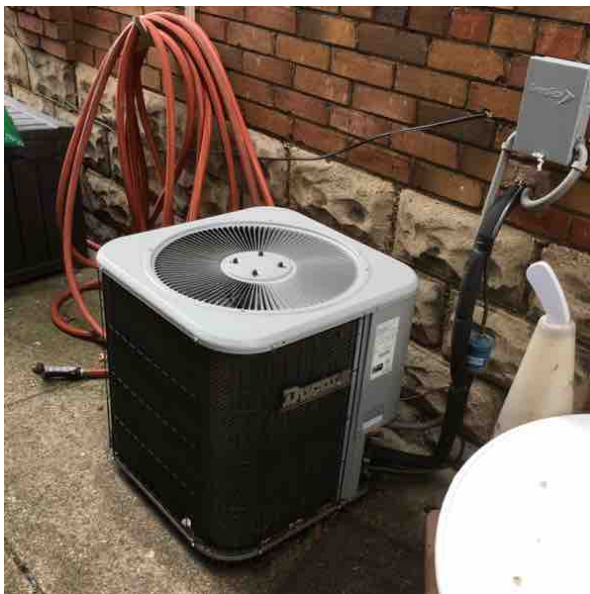
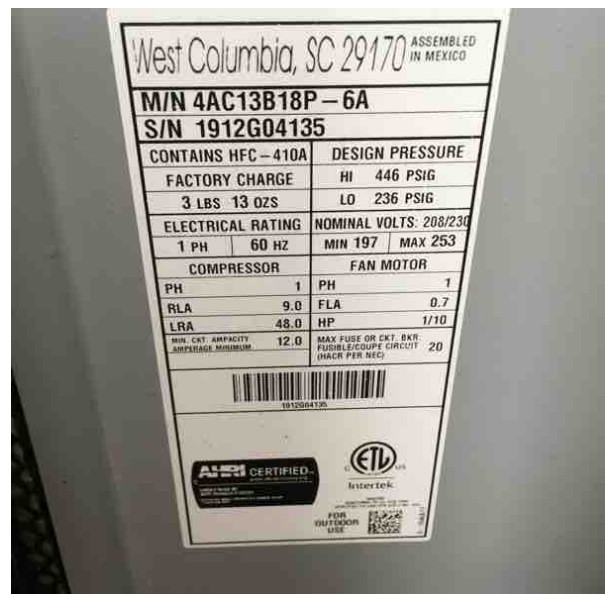
9.4.3 **Ducane AC unit has 1.5 ton cooling, 9 years old, middle of life cycle, and in satisfactory condition.**

Typical life expectancy is approx 15 years.

9.4.5 While it may be functional, recommend a HVAC technician service the unit annually to maintain performance and prolong service life.

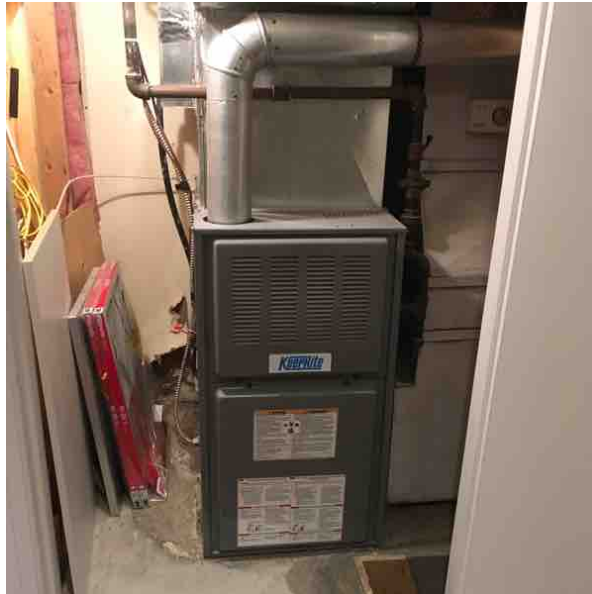
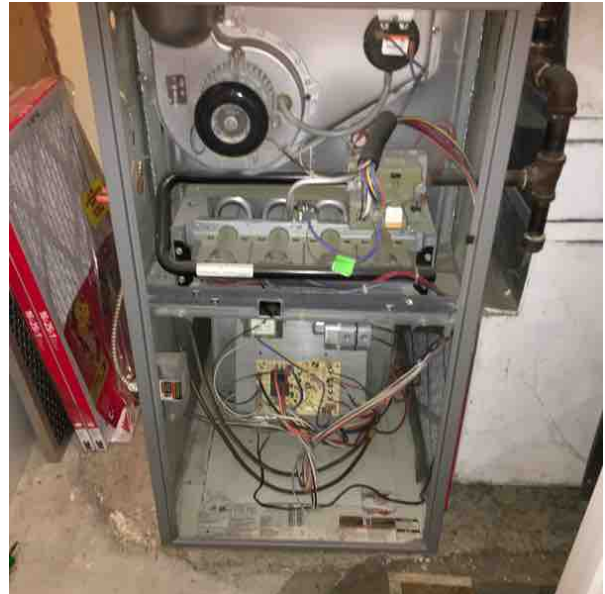
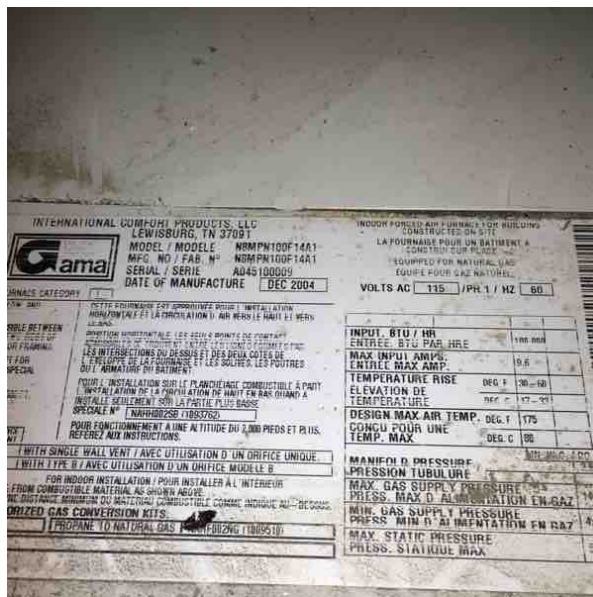
9.5.2 **Keep Rite Mid Eff furnace has 100,000 BTU / Hr Input, is 17 years old, middle of life cycle and functioning as intended.**

Typical life expectancy is 20 years.

9.5.3 While it is functional, it is dirty / dusty, recommend a HVAC technician service the unit annually to maintain performance and prolong service life.

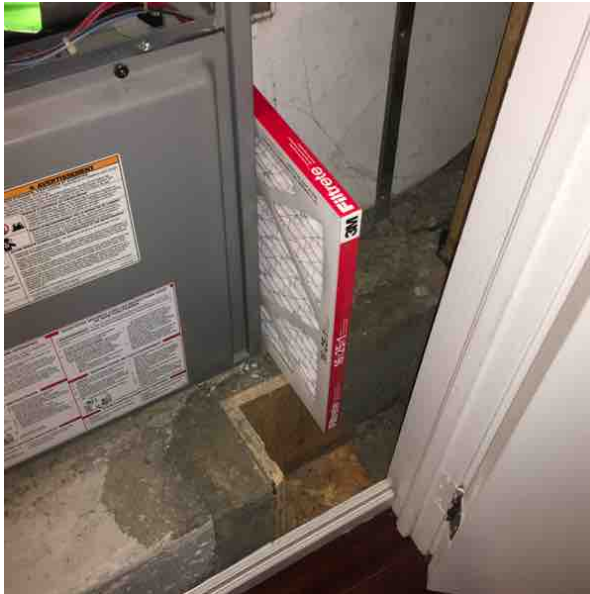
9.10.2 Disposable filter size is 16 x 25 x 1. Recommend to change once every 3 months or as per manufacture instructions.

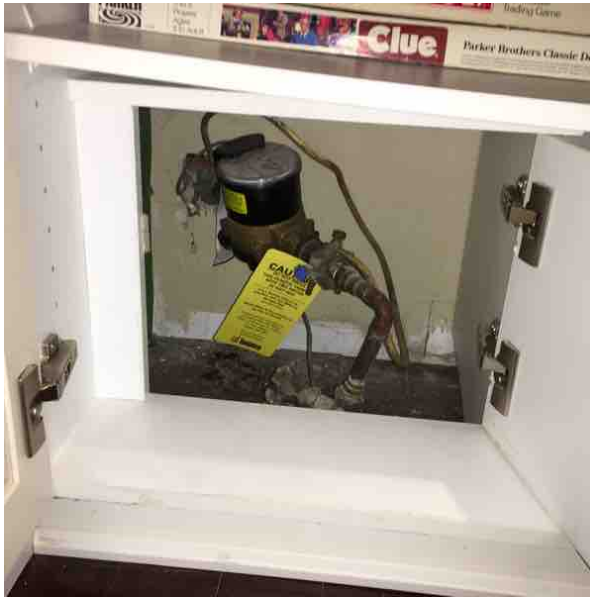
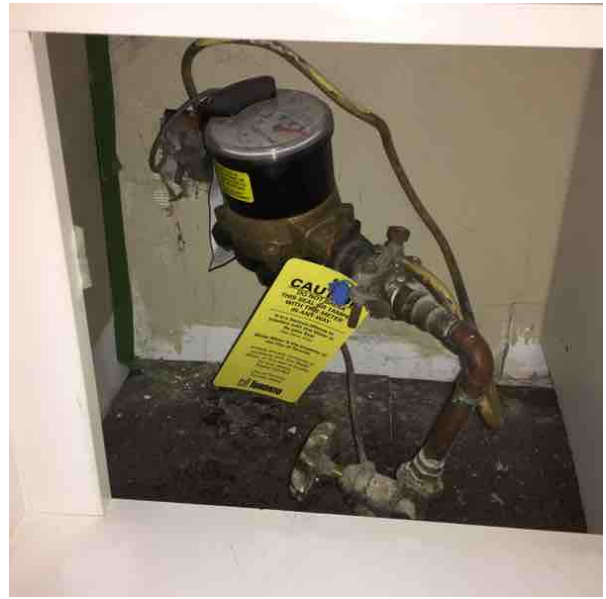
10.3.2 Estimated 1/2" Copper supply line above the meter, is located in basement utility room.

***Main shutoff for all water throughout the home is the round silver handle. Be sure to keep clear access in case of internal water emergencies.**

10.3.3 The water main pipe is only partially visible and suspected galvanized steel. A qualified plumber should further assess and upgrade / replace as required for improved water pressure / flow throughout the house and to prevent water damage due to corrosion-related water leakage.

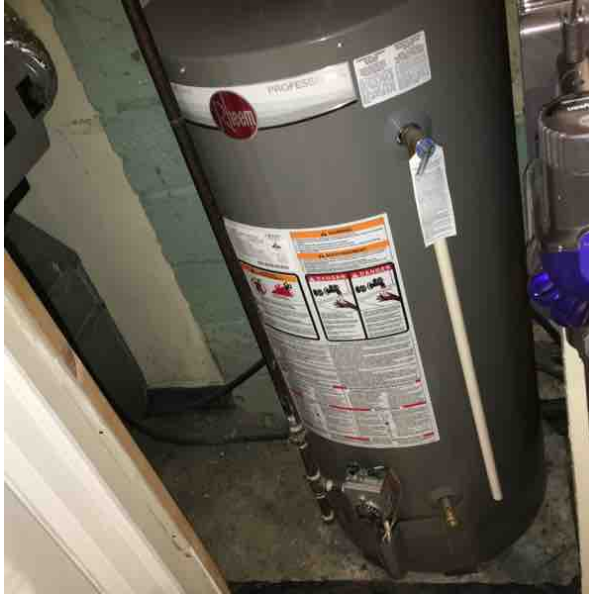
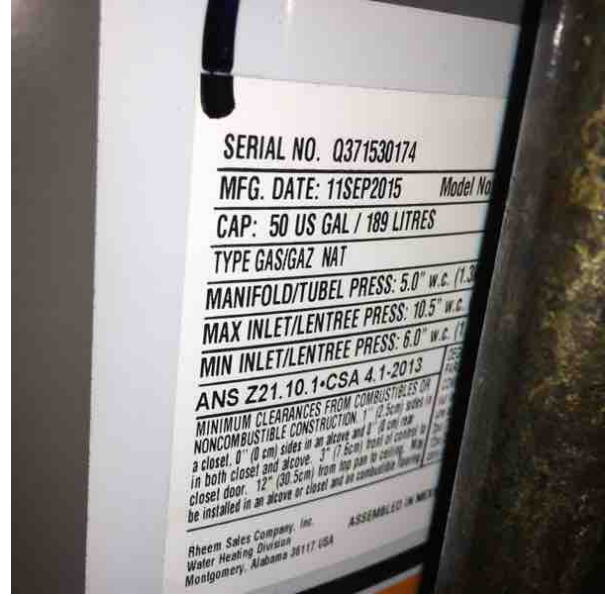
10.6.2 Rheem Hot Water tank has 50 gallon volume, is 6 years old, middle of life cycle and is functioning as intended.

Typical life expectancy is 10 - 12 years.

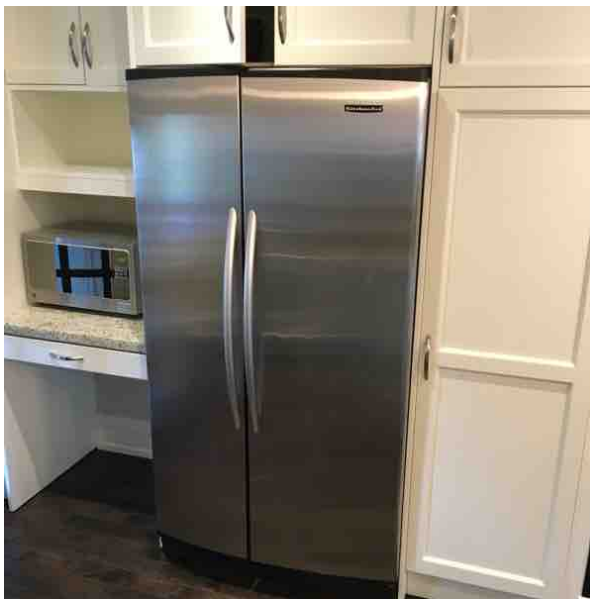
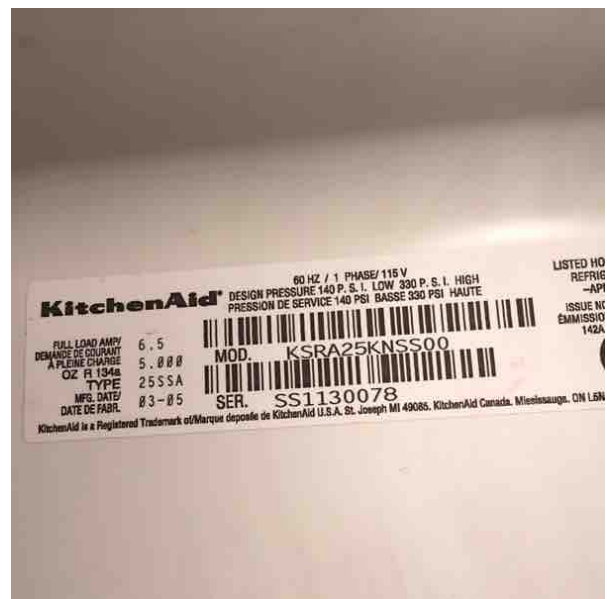
12.1.2 Kitchen Aid refrigerator/ freezer was functional.

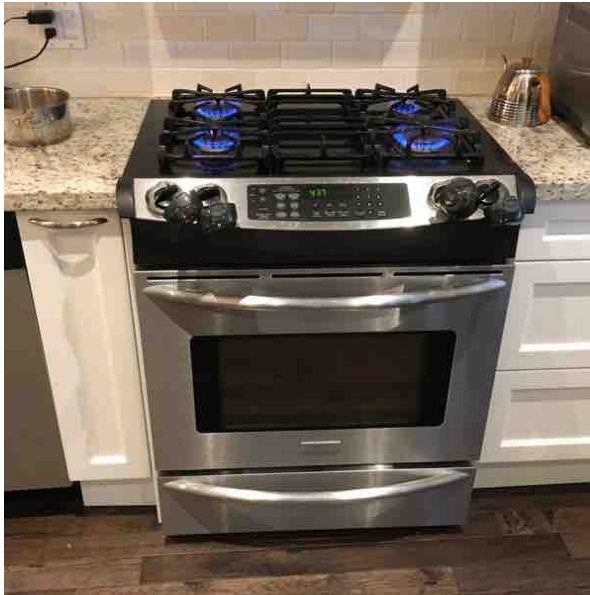
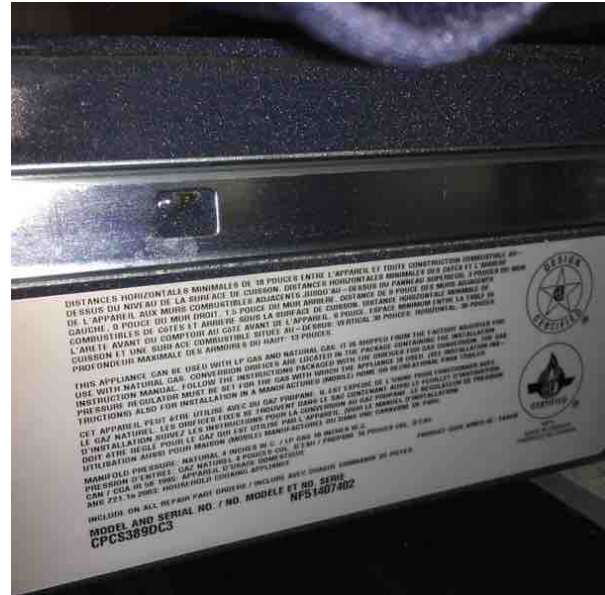
12.2.3 Frigidaire Natural gas cooktop was tested and all 4 elements were functional.

Oven not tested.

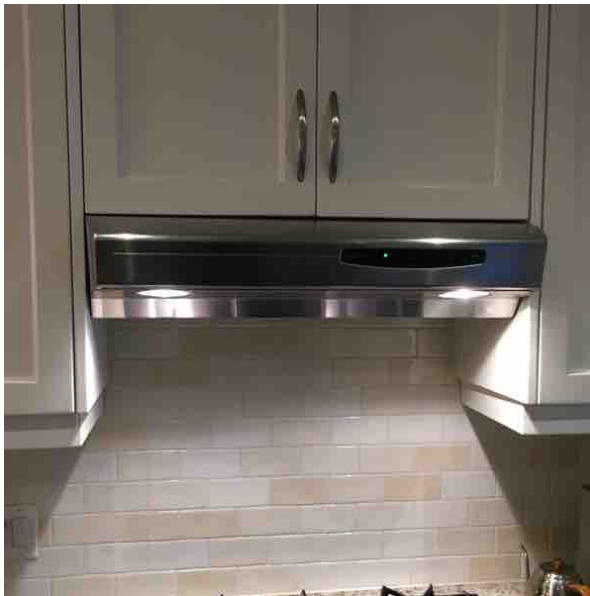
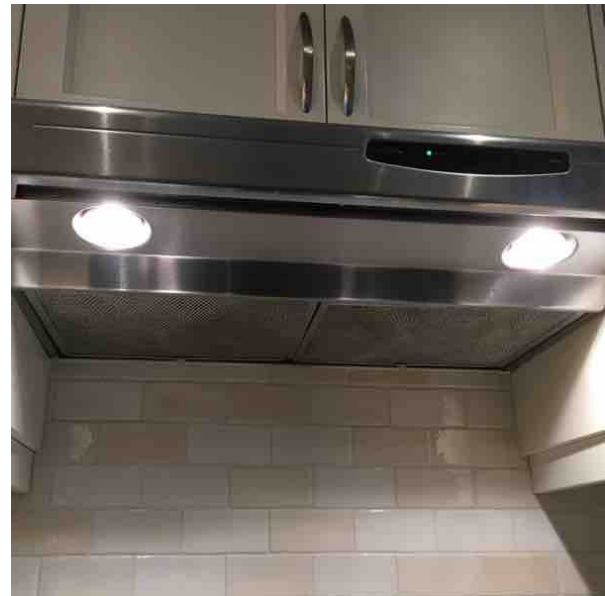
12.3.2 Range hood was tested and both fan and light features were functional.

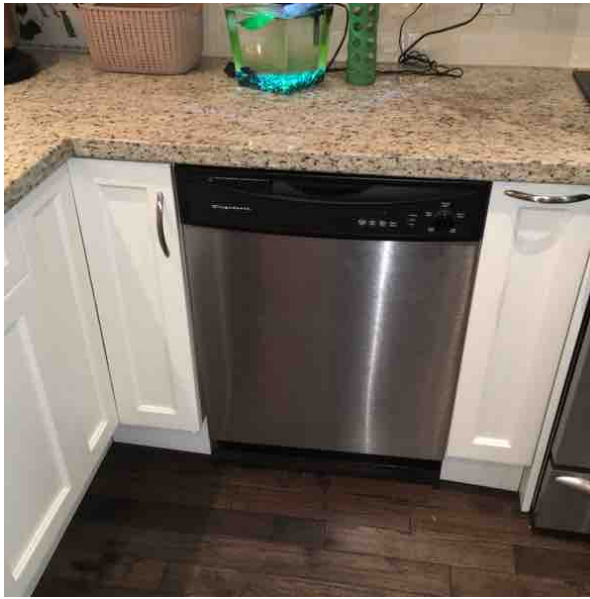
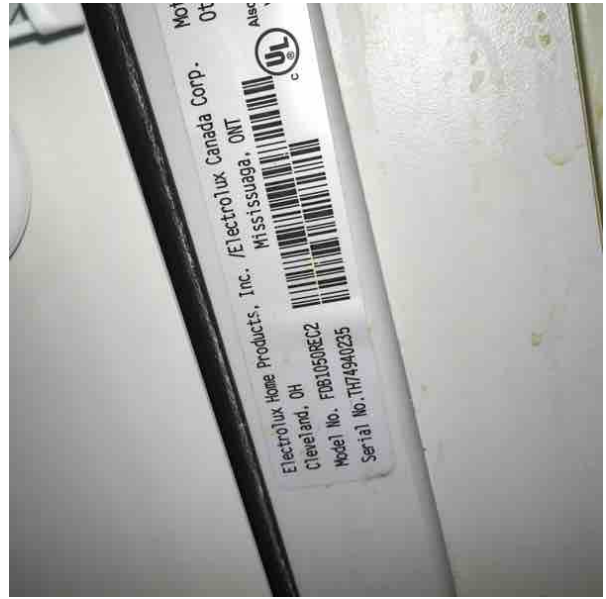
12.4.2 Frigidaire dishwasher responded to operating controls but not tested on a cycle.

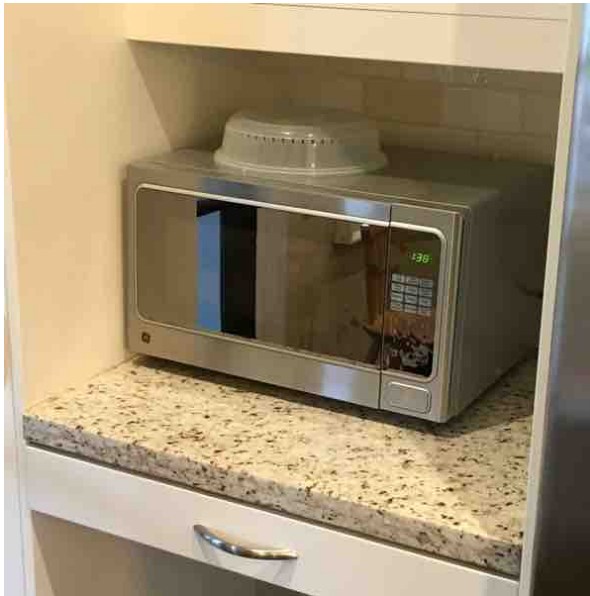
12.5.2 GE microwave was functional.
